# GEORGETOWN UNIVERSITY TOWNHOUSE EXTERIOR REPAIRS

OLD GEORGETOWN BOARD SUBMISSION – JANUARY 2023

GU PROJECT ID #: 2-C06-02

Renovations to  
3612  
O St. NW  
Washington DC.  
20007

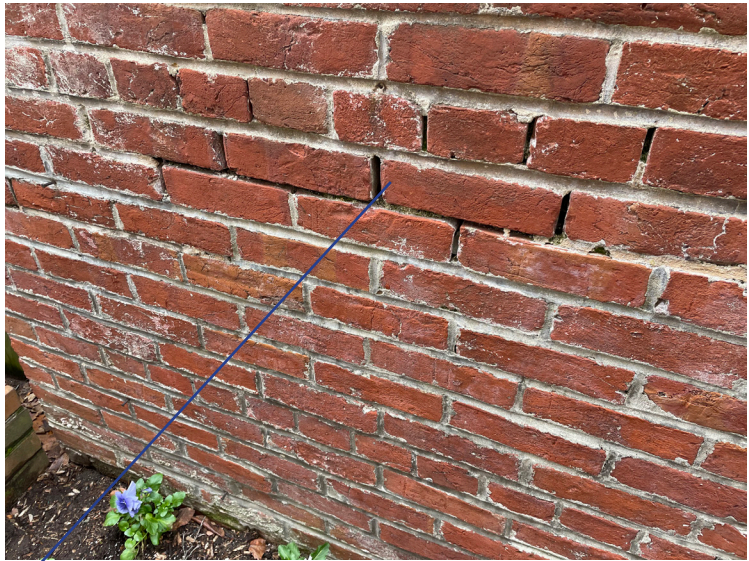
20

*The bricks in the wall are in reasonable condition with very few cracked units. There are areas of missing or damaged mortar. The termination pillar for the wall seems to have been struck by a piece of equipment that dislocated the top 6 courses of brick-this is the 'cap' to which I referred.*

- 3. Remove loose parge, patch and paint
- 7. Demo gas meter
- 8. Demo gutter and downspout
- 14. Reset misaligned pavers
- 20. Replace damaged bricks, reset dislocated bricks, repoint mortar joints with lime-based mortar

*I have added photos to further describe the corrective work we are proposing and noted use of a lime-based mortar.*

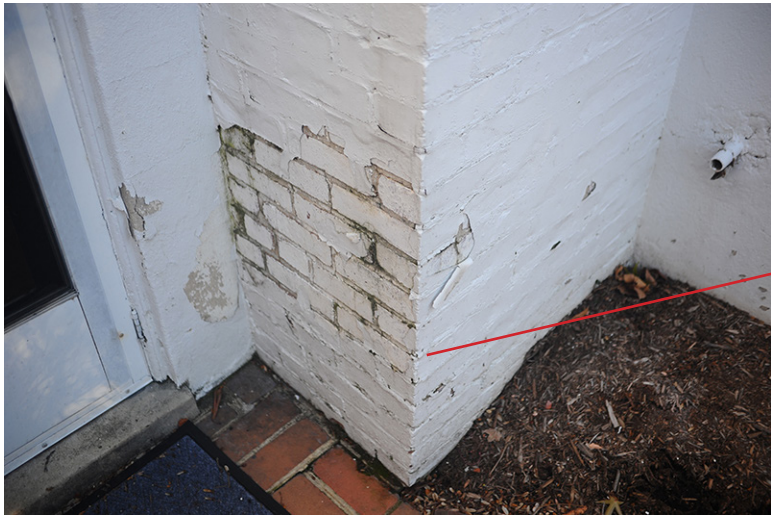
9

Image showing general condition of alley wall

*Additional photographs of the side (alley) wall show the wall to be in reasonably good repair. The chimney seems to be the location with the most brick damage. We do not propose extensive rebuilding or repointing. We will contact a masonry supply company to determine if a matching brick is available.*
