LINCOLN MEMORIAL REHABILITATION:

COMMISSION OF FINE ARTS REVIEW

JUNE 4TH, 2020

QUINN EVANS

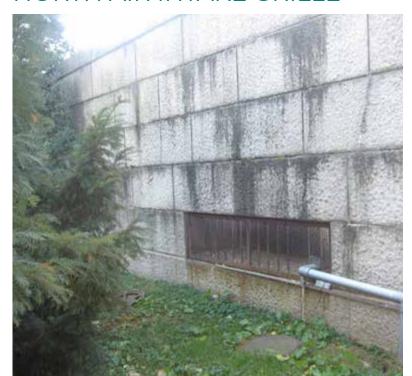
1 - EXISTING VENT

NORTH AIR INTAKE GRILLE

Originally only two openings, ventilation grilles on the north and south sides, existed in the granite terrace retaining wall. These openings are simplistic in form; comprising of only a single "missing" course of granite with a metal grille installed for ventilation. In the original 1913 drawings by Henry Bacon, the interior Undercroft mezzanine extended to these vents, possibly as entry and exit points for construction; these extensions were never built.

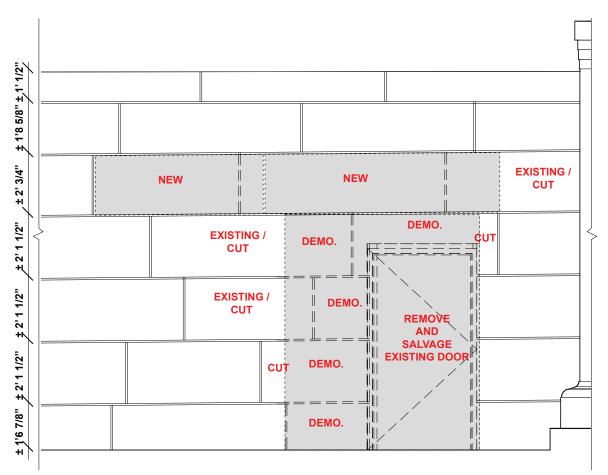
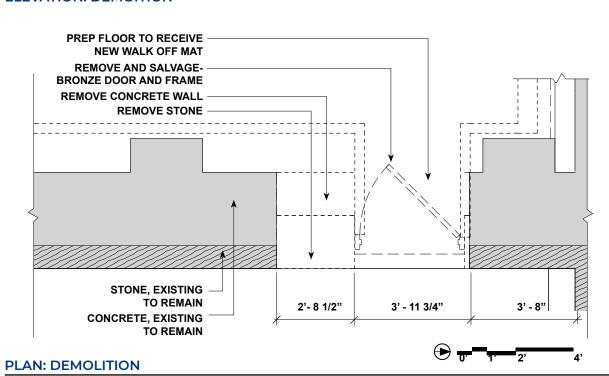
ELEVATION: DEMOITION

ENLARGED ELEVATION AND PLAN - SOUTH EAST GATES - OPTION A (STONE LINTEL)

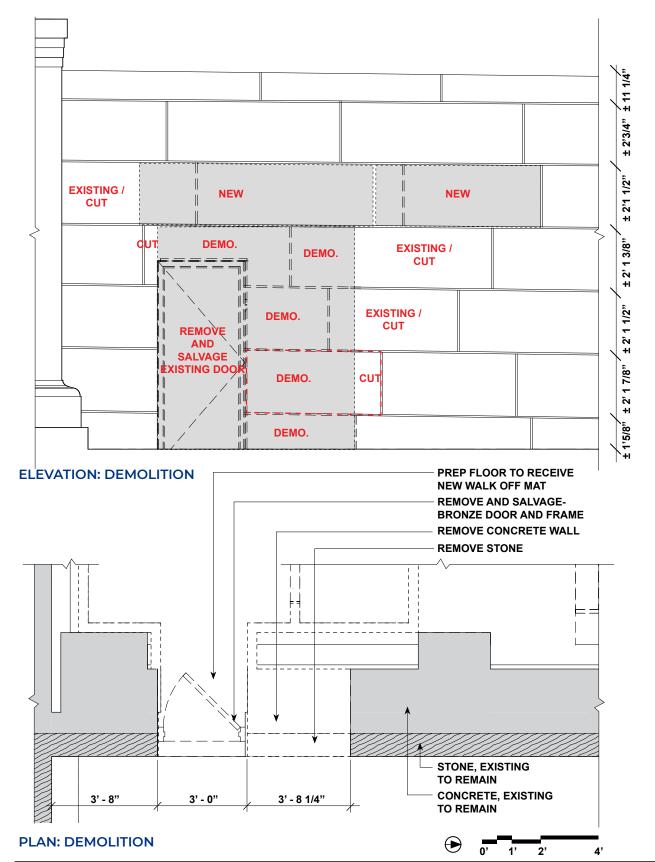
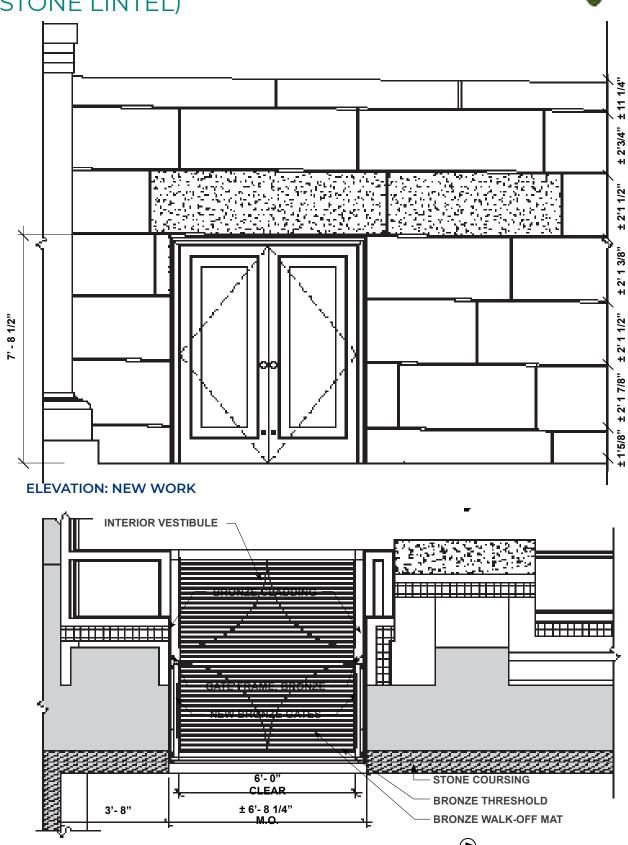
PLAN: NEW WORK

ENLARGED ELEVATION AND PLAN - NORTH EAST GATES - OPTION A (STONE LINTEL)

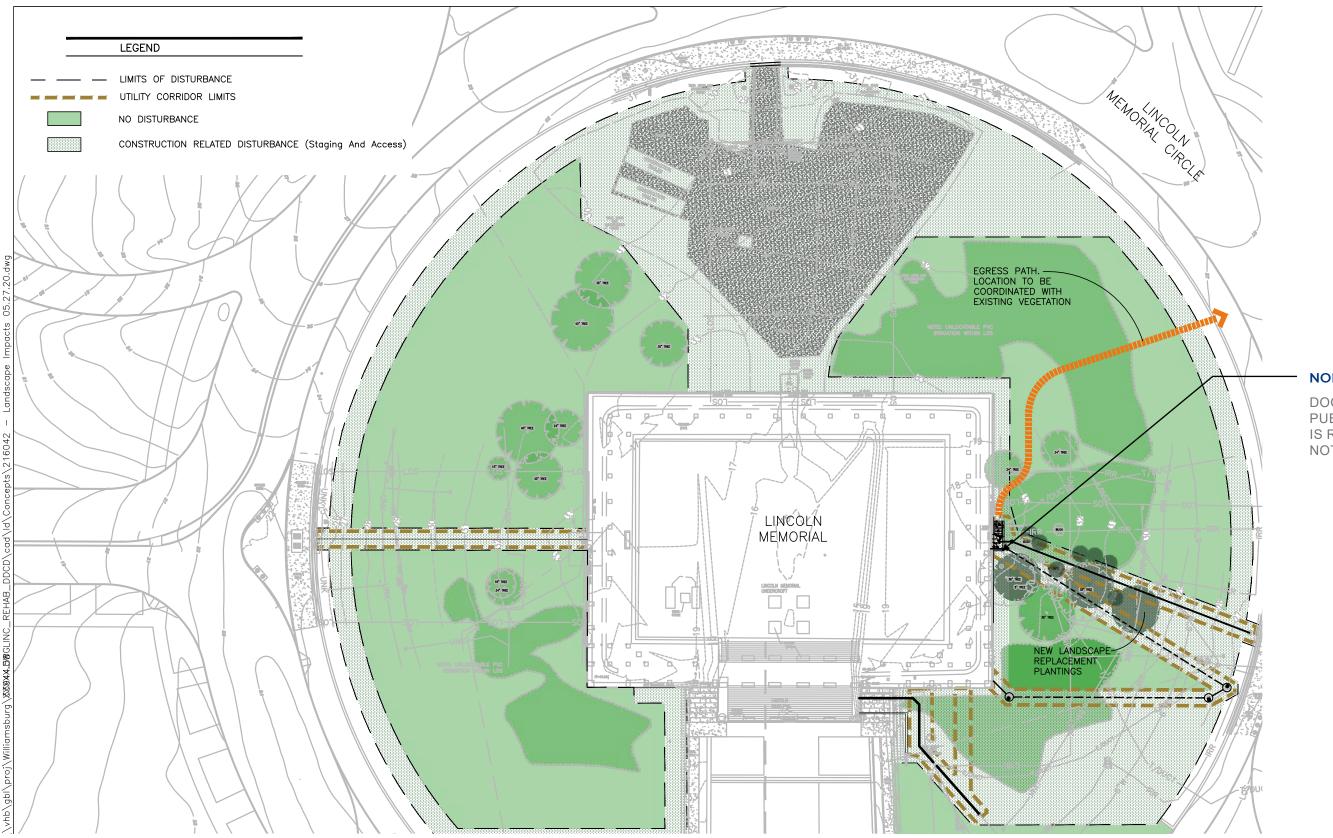
NORTH DOOR EXITING PLAN

NORTH EXIT DOOR

DOOR EXITS DIRECTLY TO A PUBLIC WAY. NO SIDE WALK IS REQUIRED AND ONE WILL NOT BE PROVIDED.

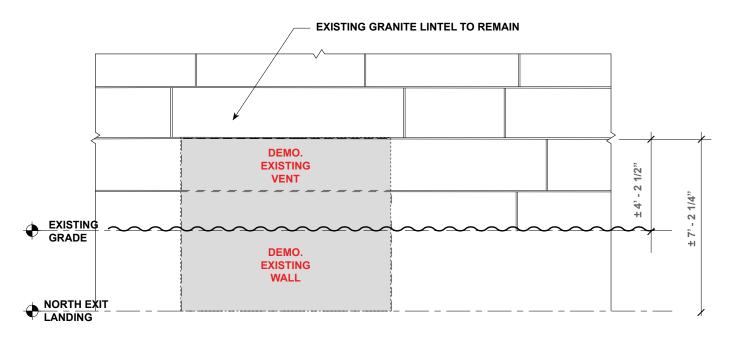
ELEVATION - COURSING DEMOLITION DIAGRAM

ENLARGED ELEVATION - DEMOLITION - NORTH EXIT DOOR

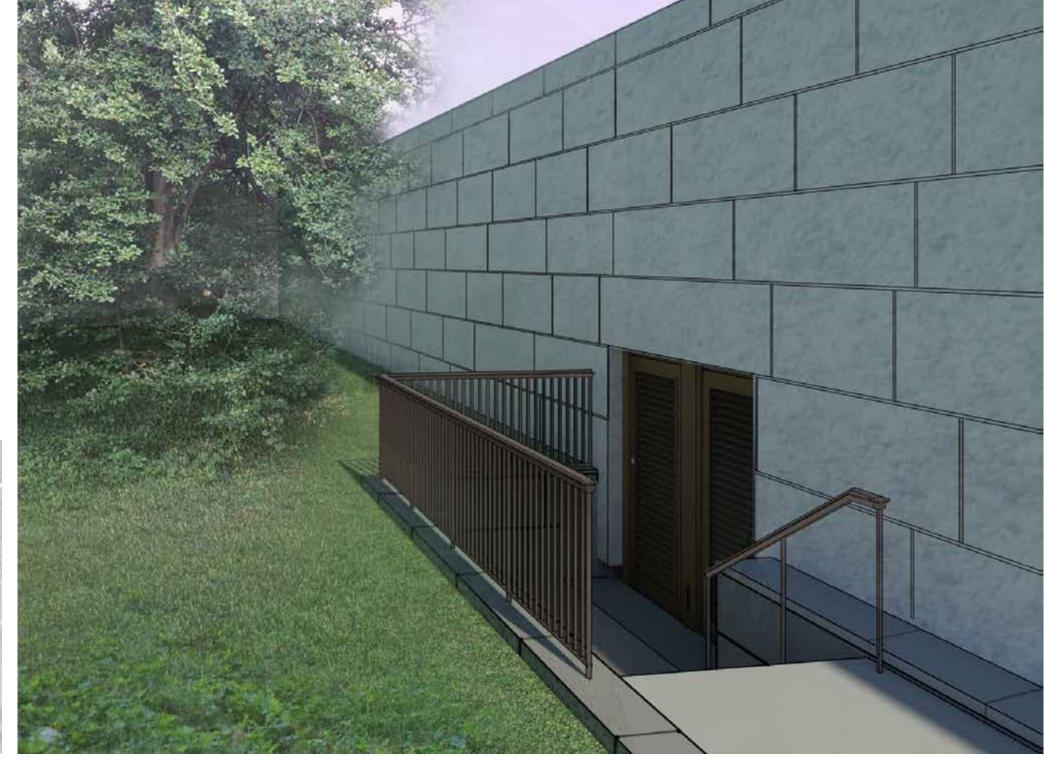
PROPOSED NORTH EXIT DOOR VISUALIZATION

COMPUTER VISUALIZATION
