# GEORGETOWN UNIVERSITY TOWNHOUSE EXTERIOR REPAIRS

OLD GEORGETOWN BOARD SUBMISSION - JANUARY 2023

GU PROJECT ID #: 2-D07-03

Renovations to 3619

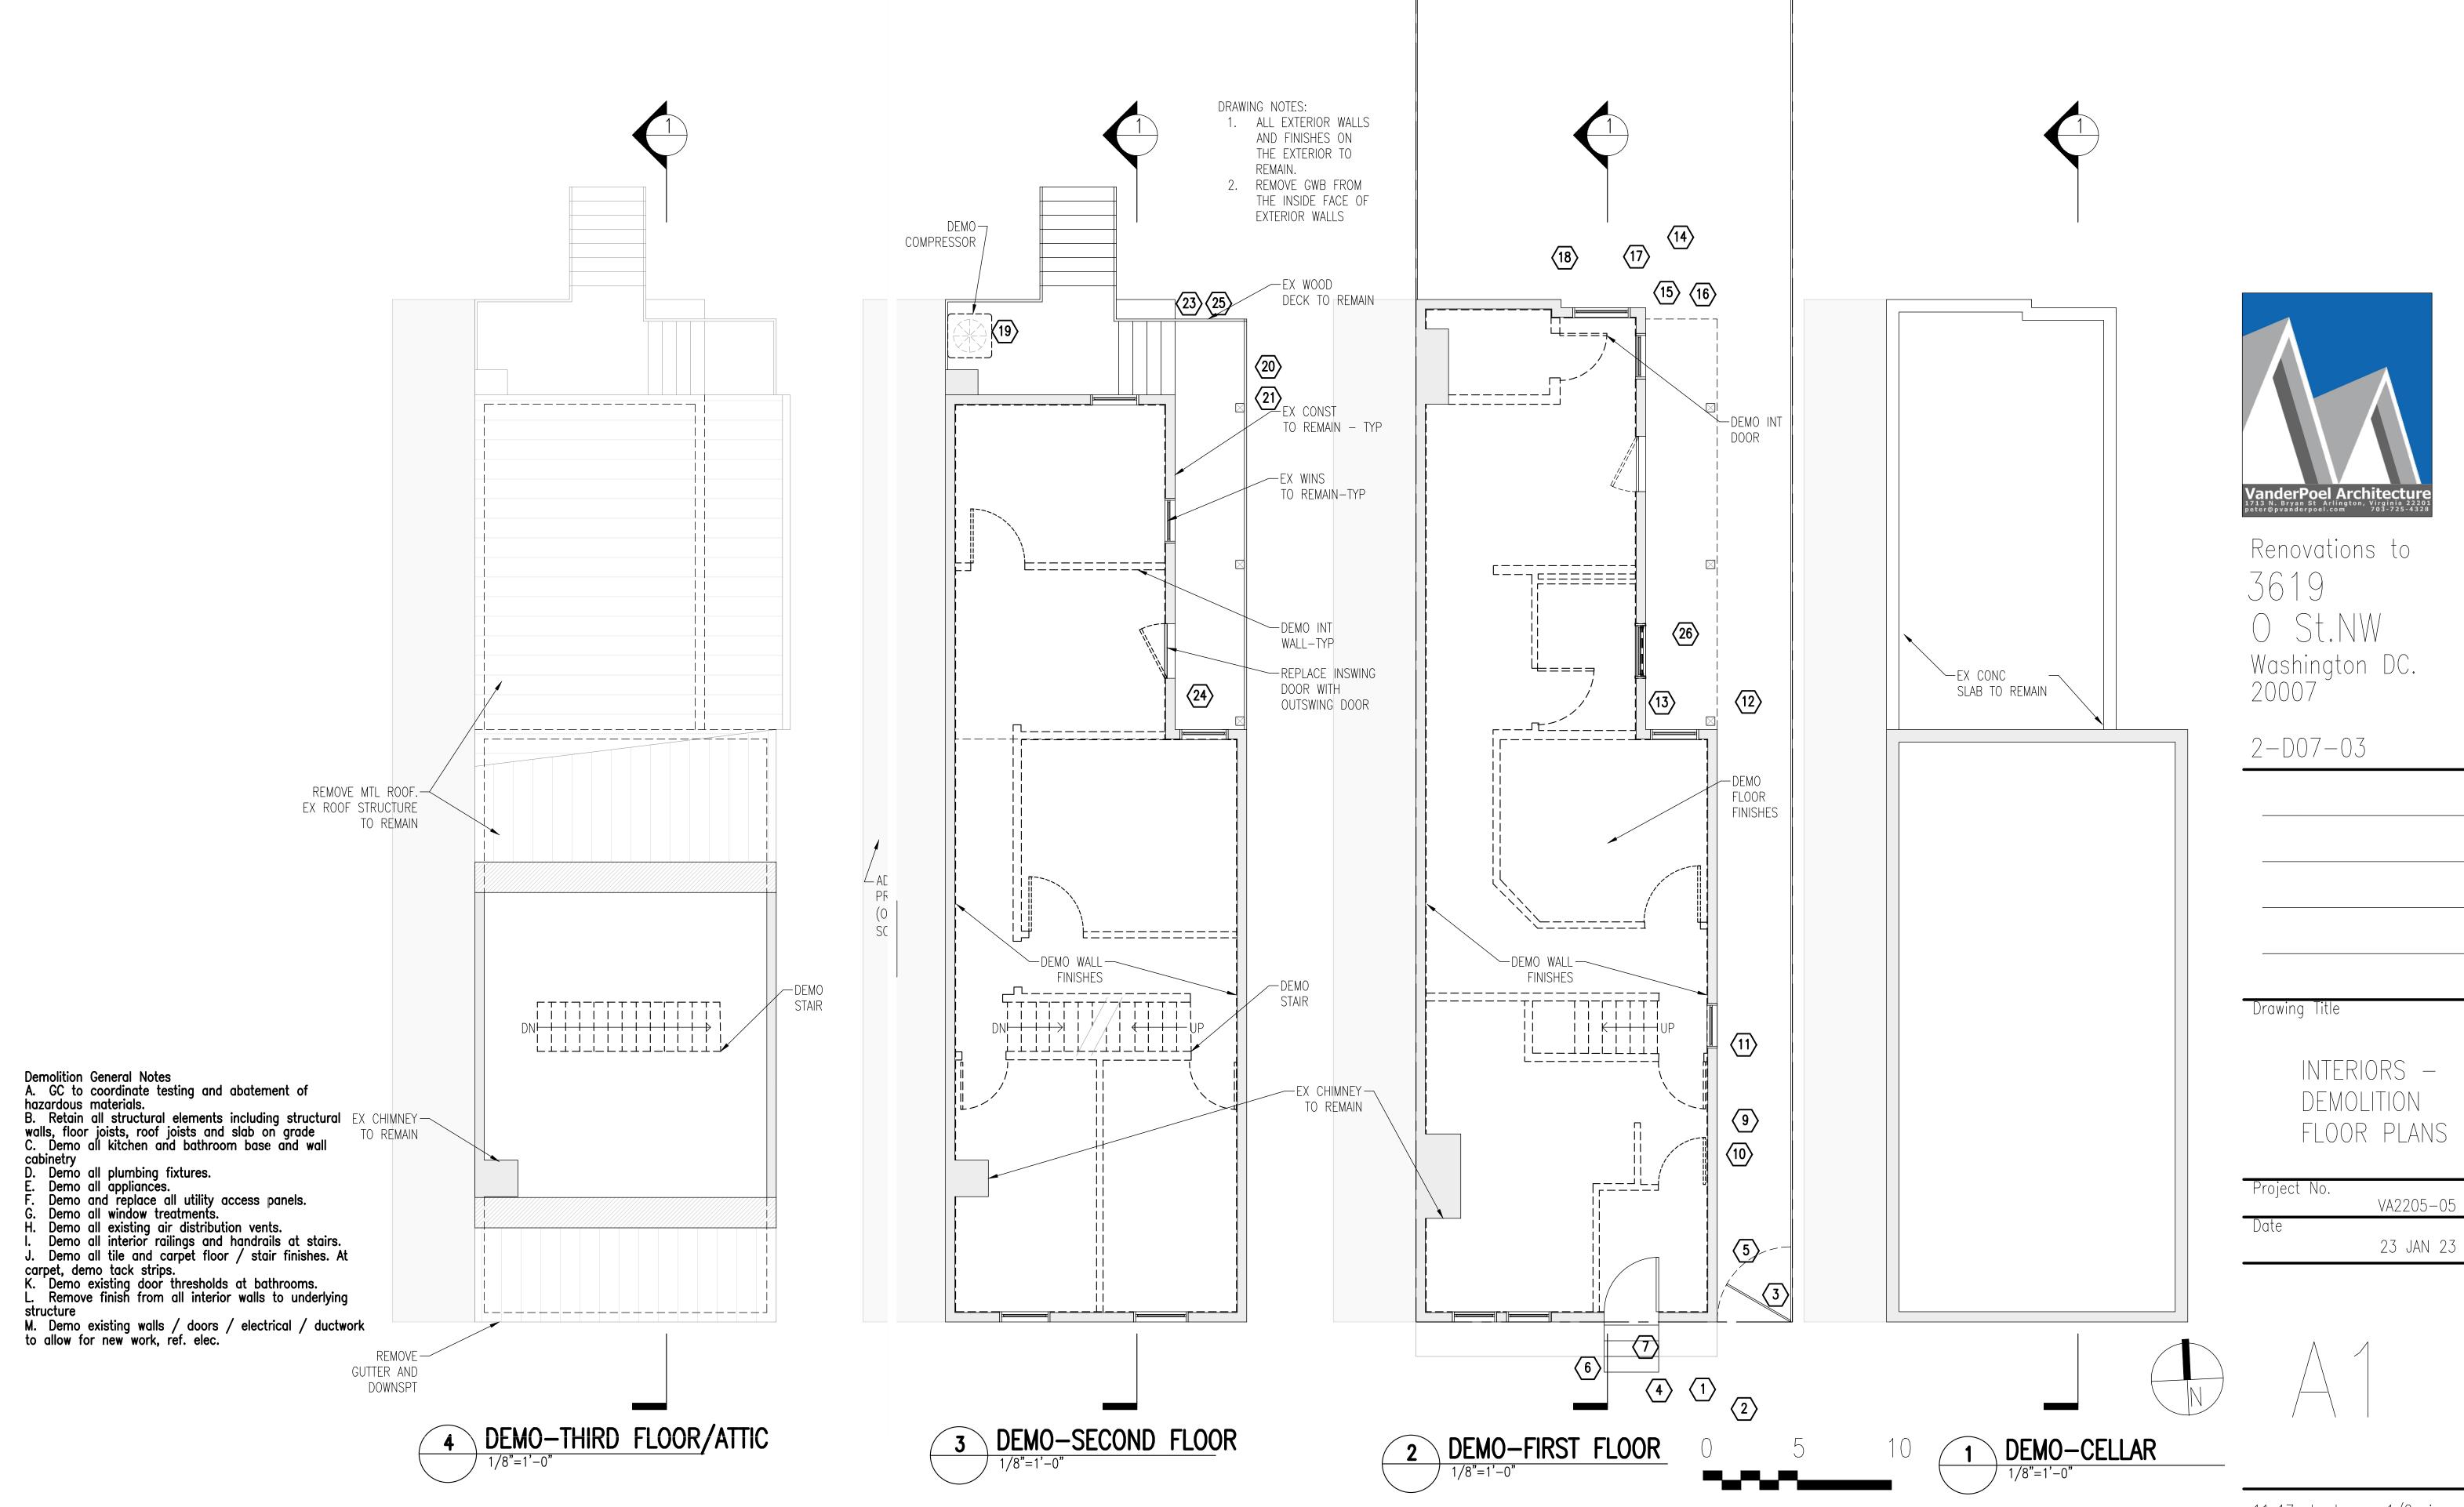
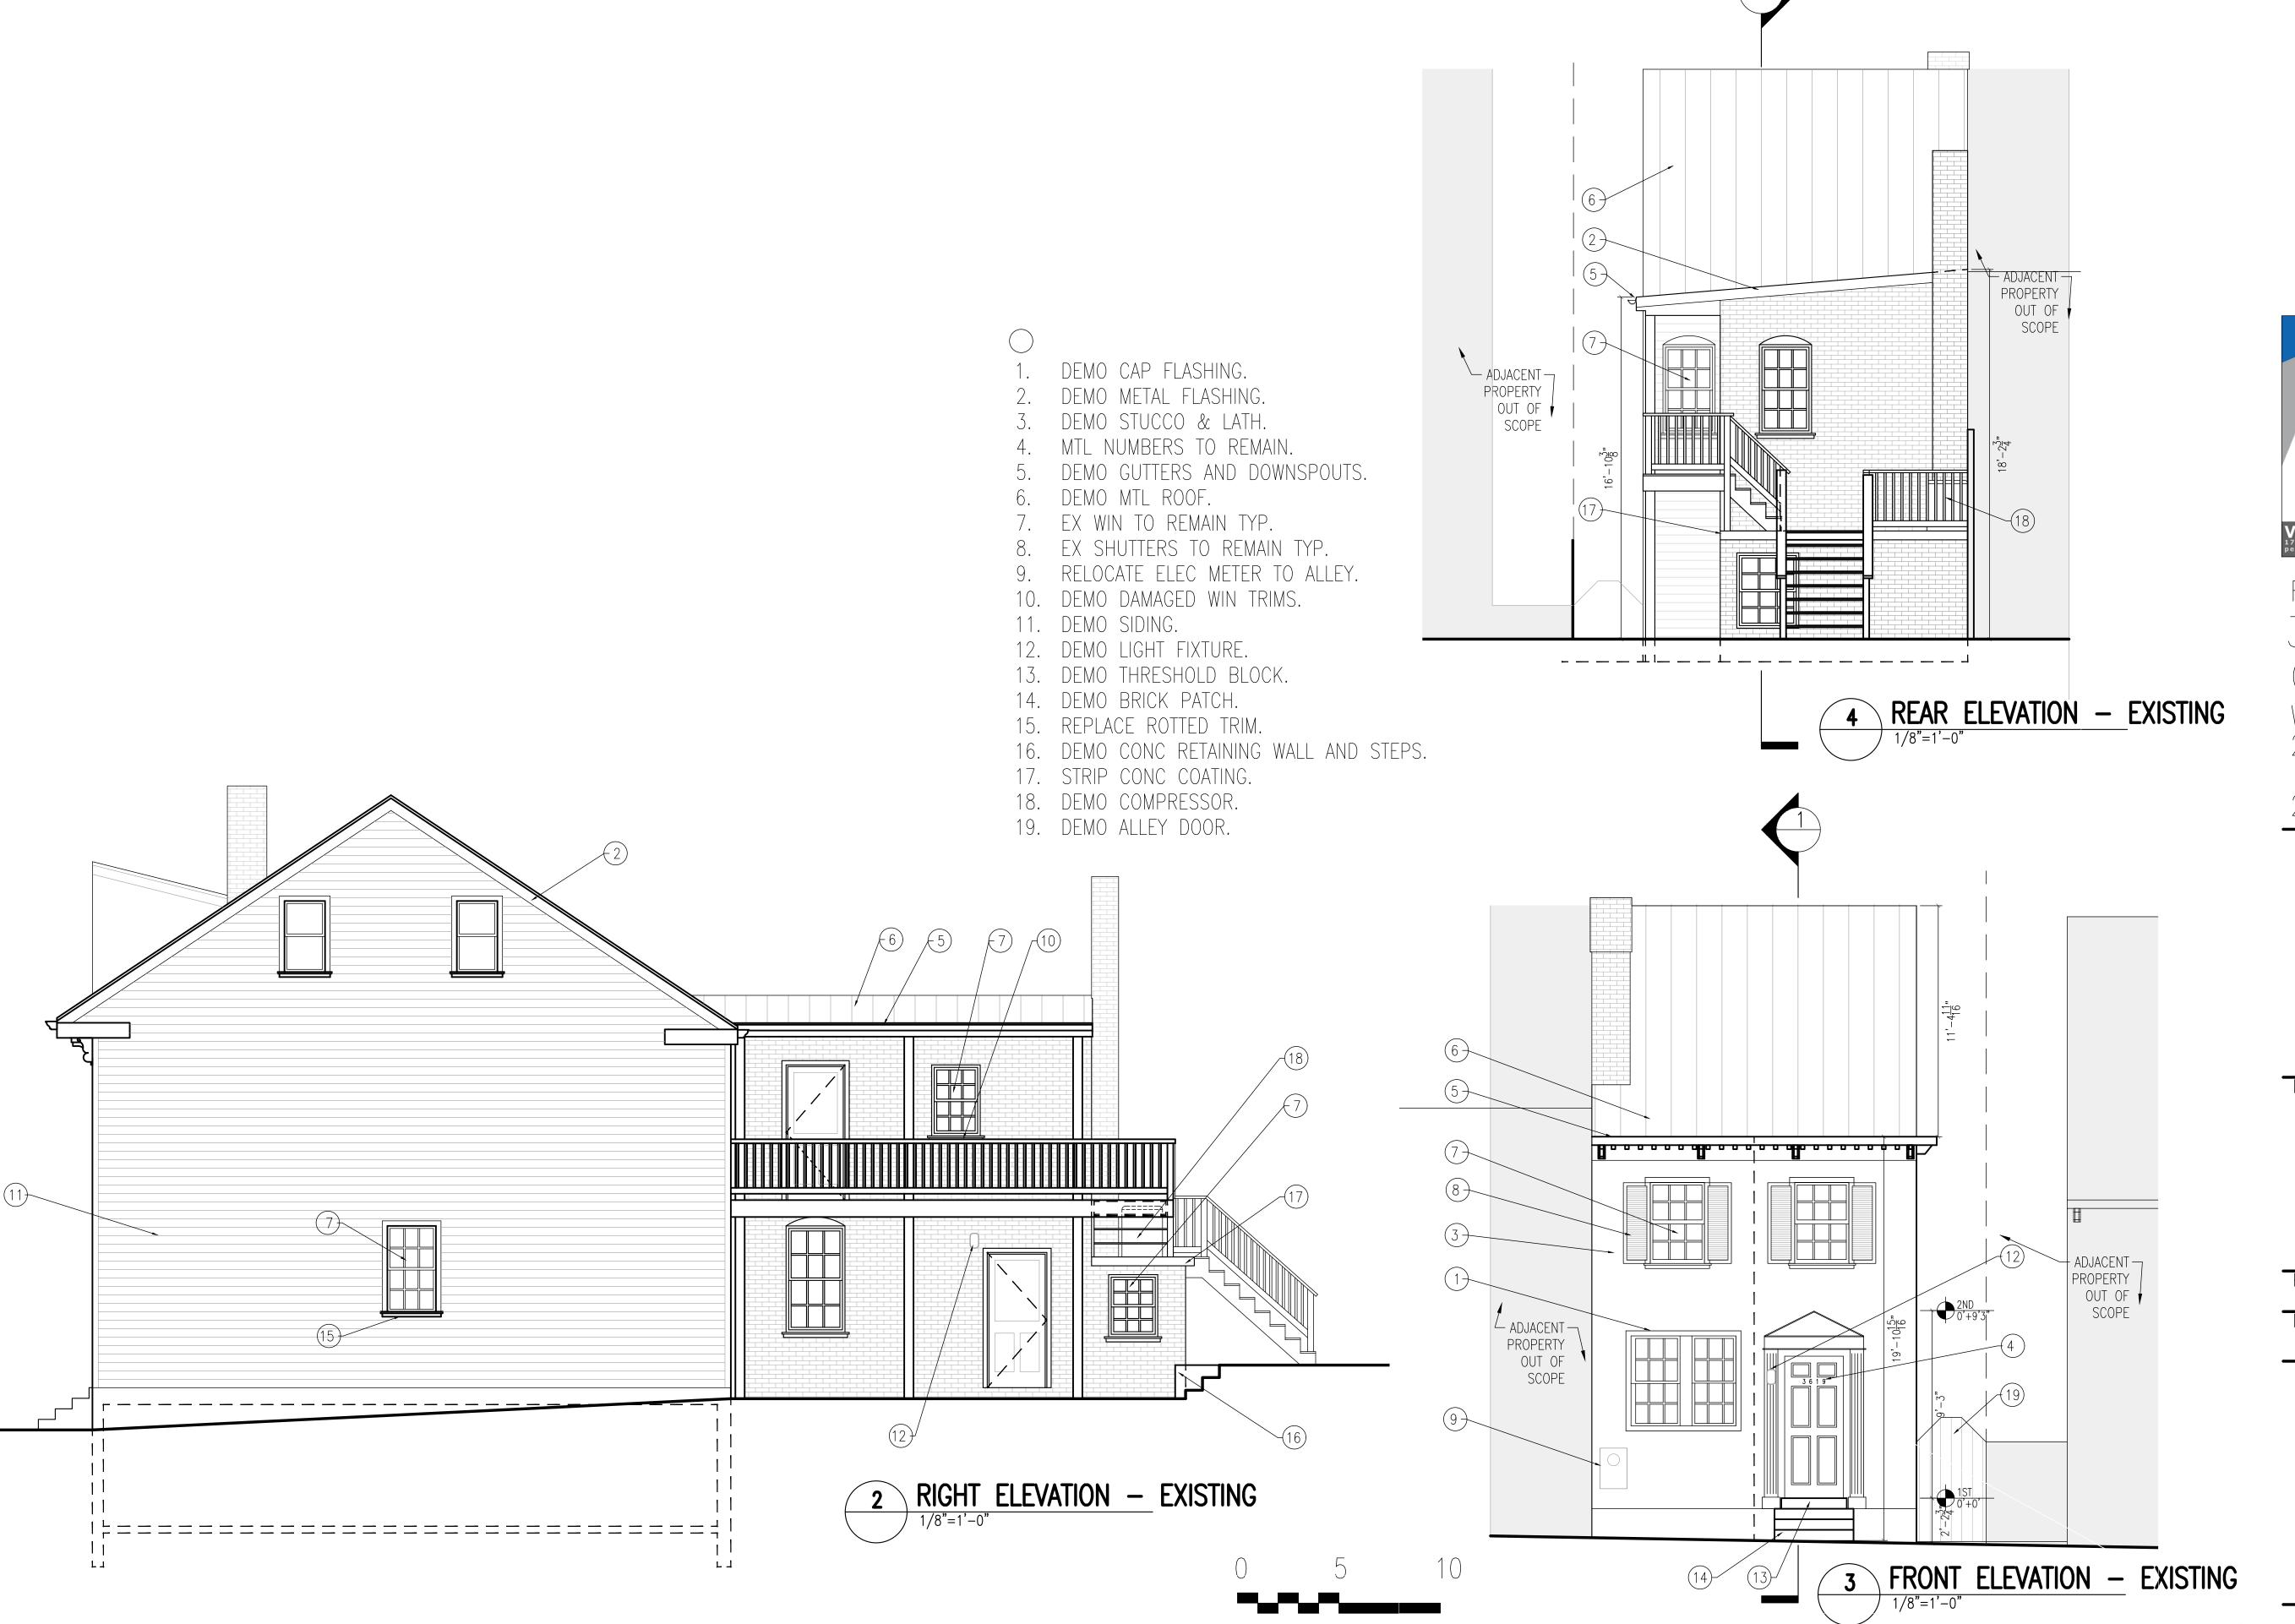
BUILDING ELEVATIONS — EXISTING

Existing flashing detail east face of neighboring structure

West face of neighboring structure showing proposed siding detail

- 1. Demo roof flashing and roofing
- 2. Demo stucco finish and lath
- 3. Remove loose parge, patch and paint
- 4. Existing window to remain-typical
- 5. Remove, refinish and reinstall existing shutters-typical
- 6. Demo ext light fixture
- 8. Demo gutter and downspout
- 11. Demo conc threshold block- provide limestone block
- 12. Demo siding
- 15. Sand, refinish and resinstall door
- 17. Sand and repaint wood trim-typical
- 25. Remove mtl flashing. Provide 5" german profile lap siding and trim similar to Image #29. Flash new roof under new siding.

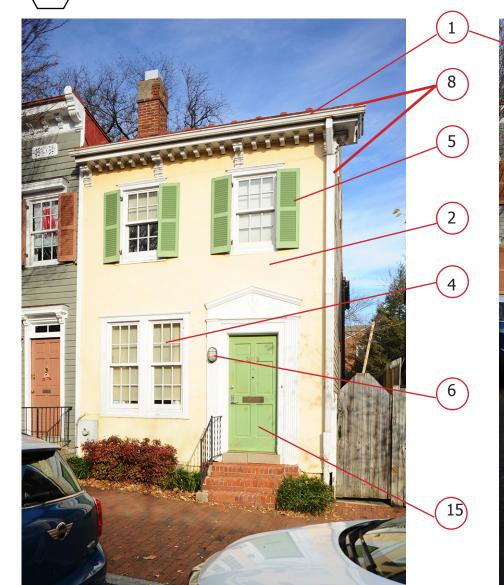
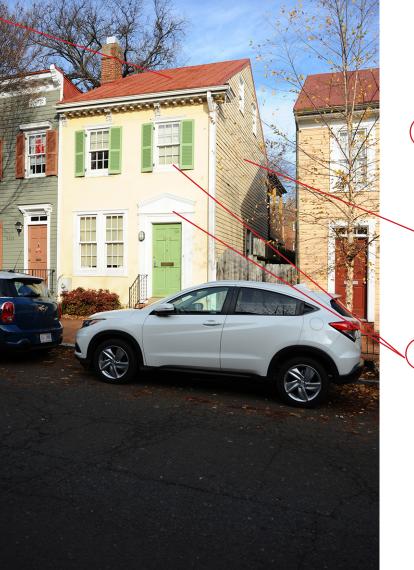
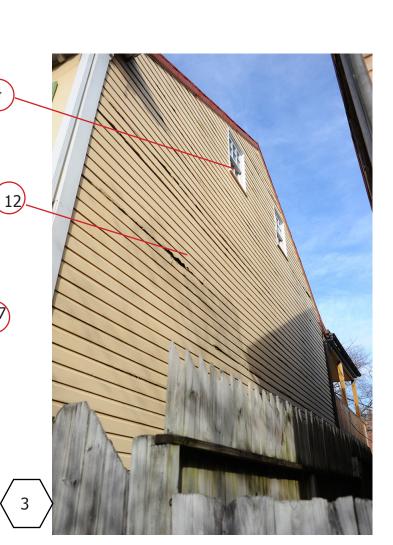
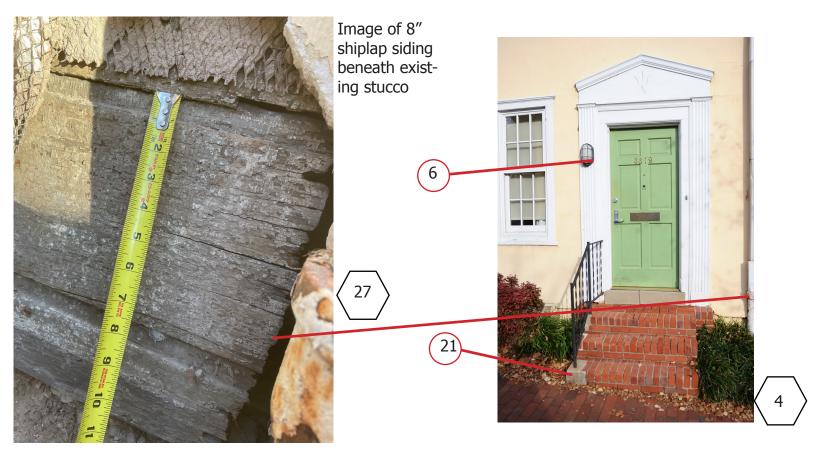
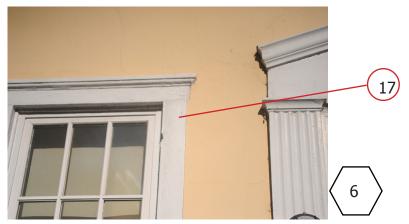
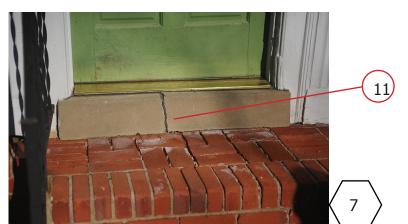
### PHOTO REFERENCES

- 2. Demo stucco finish and lath
- 4. Existing window to remain
- 6. Demo ext light fixture
- 11. Demo conc threshold block- provide limestone block
- 15. Sand, refinish and resinstall door 17. Sand and repaint wood trim
- 19. Replace rotted wood trim20. Replace foundation vents
- 21. Remove conc patch-install brick treads

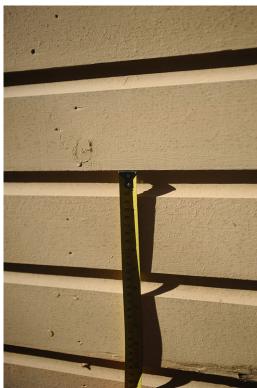
#### PHOTO REFERENCES

Photo depicting german existing german profile siding

- 17. Patch, sand and repaint wood trim19. Replace rotted wood trim20. Replace foundation vents21. Remove conc patch-install brick treads22. Sand and Paint existing metal ramp guards

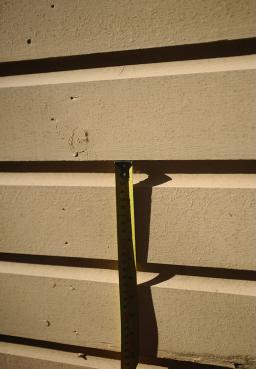
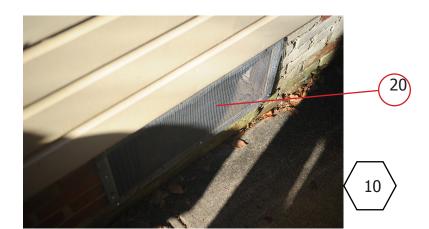
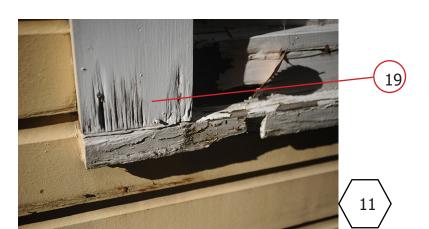
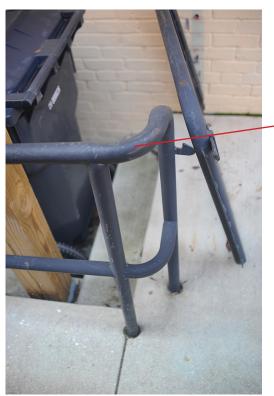
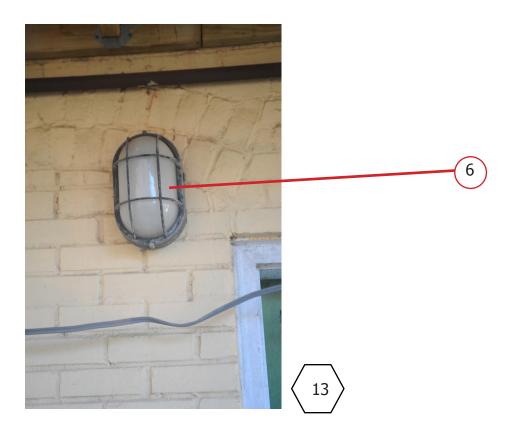
AP3

- 6. Demo ext light fixture
- 10. Route cabling inside house
  12. Demo conc/tile retaining wall and provide 2
  wythe brick retaining wall
  14. Reset misaligned pavers
  16 Repair damaged mortar
  19. Replace rotted wood trim
  21. Remove cons stops install brick treads
- 21. Remove conc steps-install brick treads23. Flash patch tread

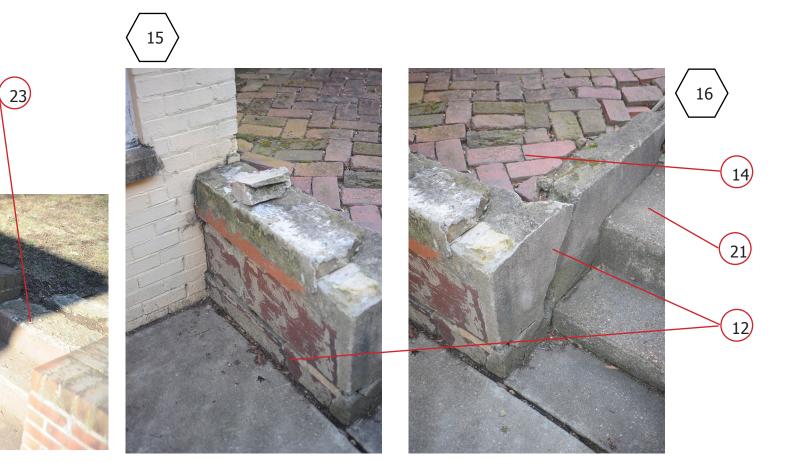
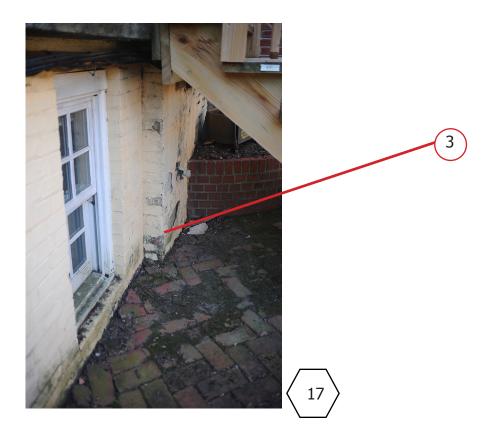
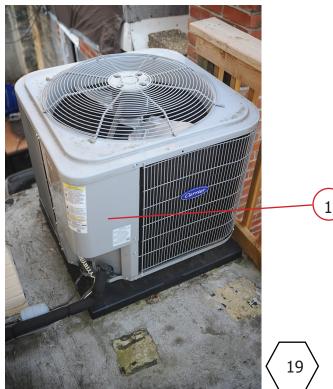
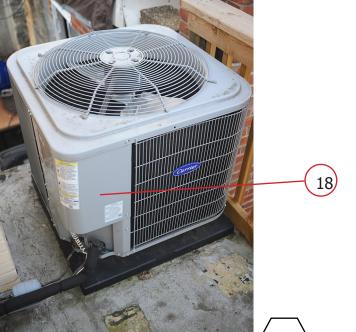
PHOTO REFERENCES

- 3. Remove loose parge, patch and paint
  14. Reset misaligned pavers
  17. Sand and repaint wood trim
  18. Demo compressor
  24. Paint existing wood deck, posts and balusters

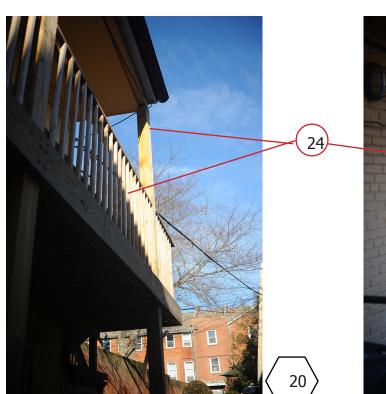
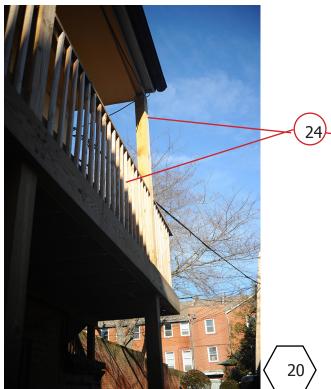
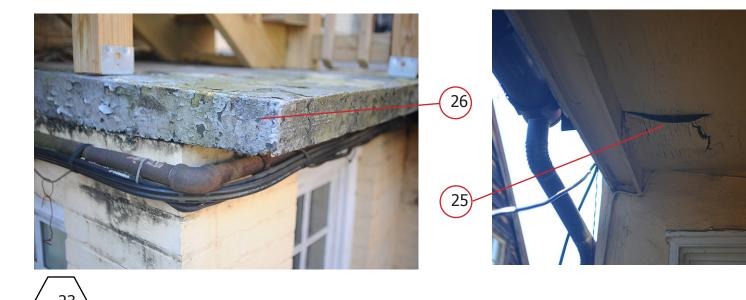
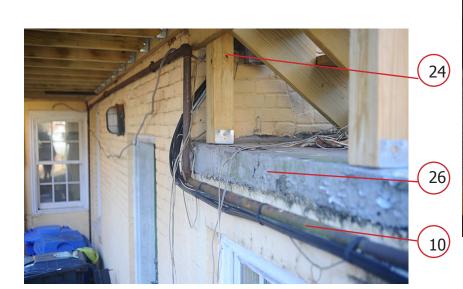
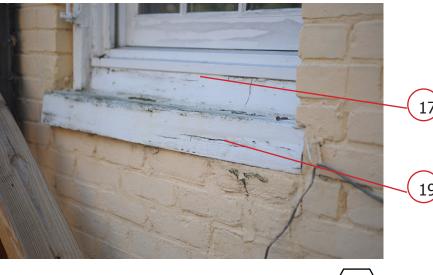
AP5

## **Demolition Notes**

- 3. Remove loose parge, patch and paint
- 10. Route cabling inside house
  17. Sand and repaint wood trim
  19. Replace rotted wood trim

- 24. Paint existing wood deck, posts and balus-
- 25. Replace entire porch ceiling w/ bead board marine grade plywd-paint
- 26. Remove conc waterproofing, provide new coating

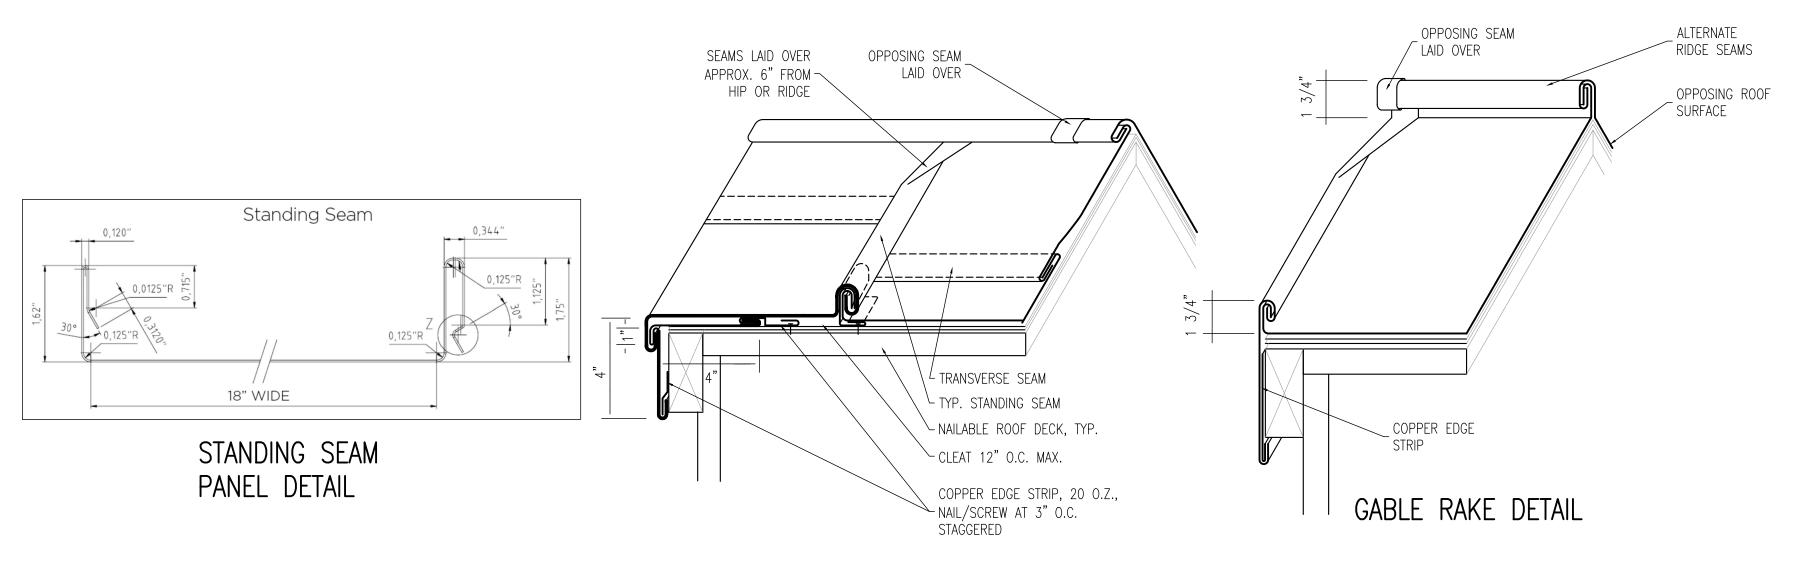
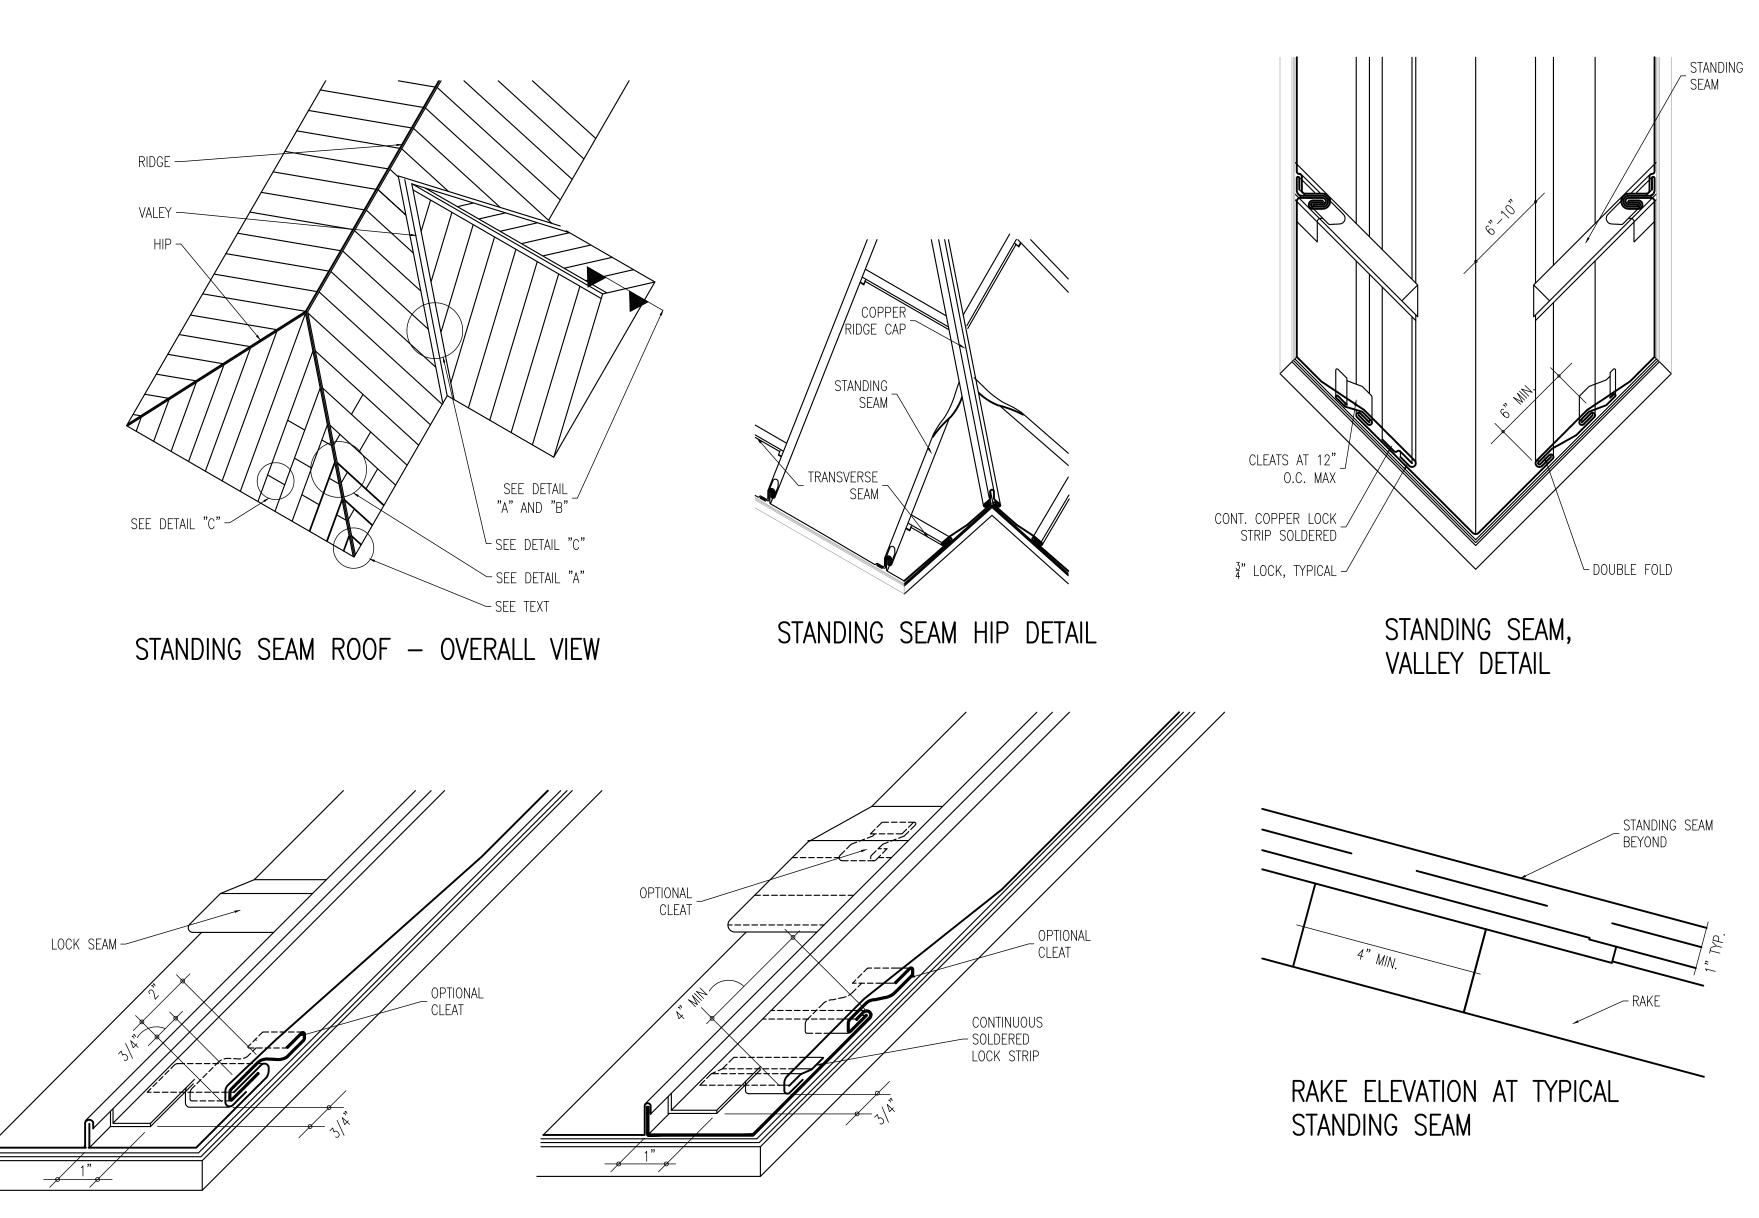
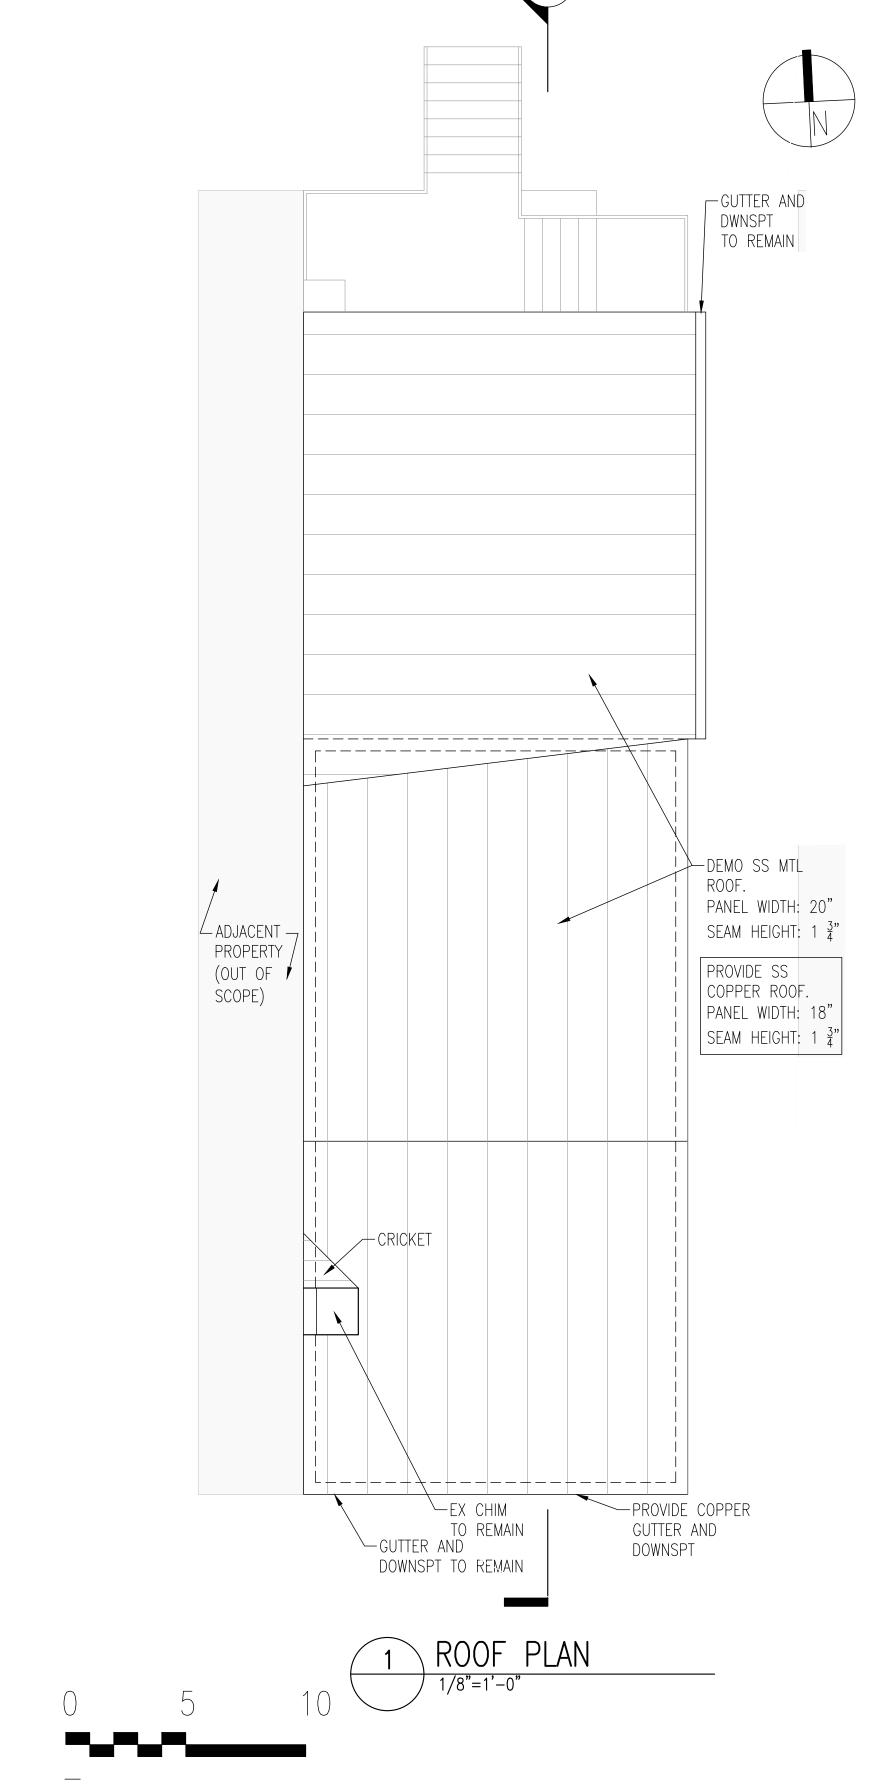
ROOF PLAN AND DETAILS

# TYPICAL STANDING SEAM

LOW PITCH DETAIL

STEEP PITCH DETAIL

> Information regarding the roof seam height and spacing has been added to the drawings. See A6
