# GEORGETOWN UNIVERSITY TOWNHOUSE EXTERIOR REPAIRS

OLD GEORGETOWN BOARD SUBMISSION – JANUARY 2023

GU PROJECT ID #: 2-C06-02

Renovations to  
3612  
O St. NW  
Washington DC.  
20007

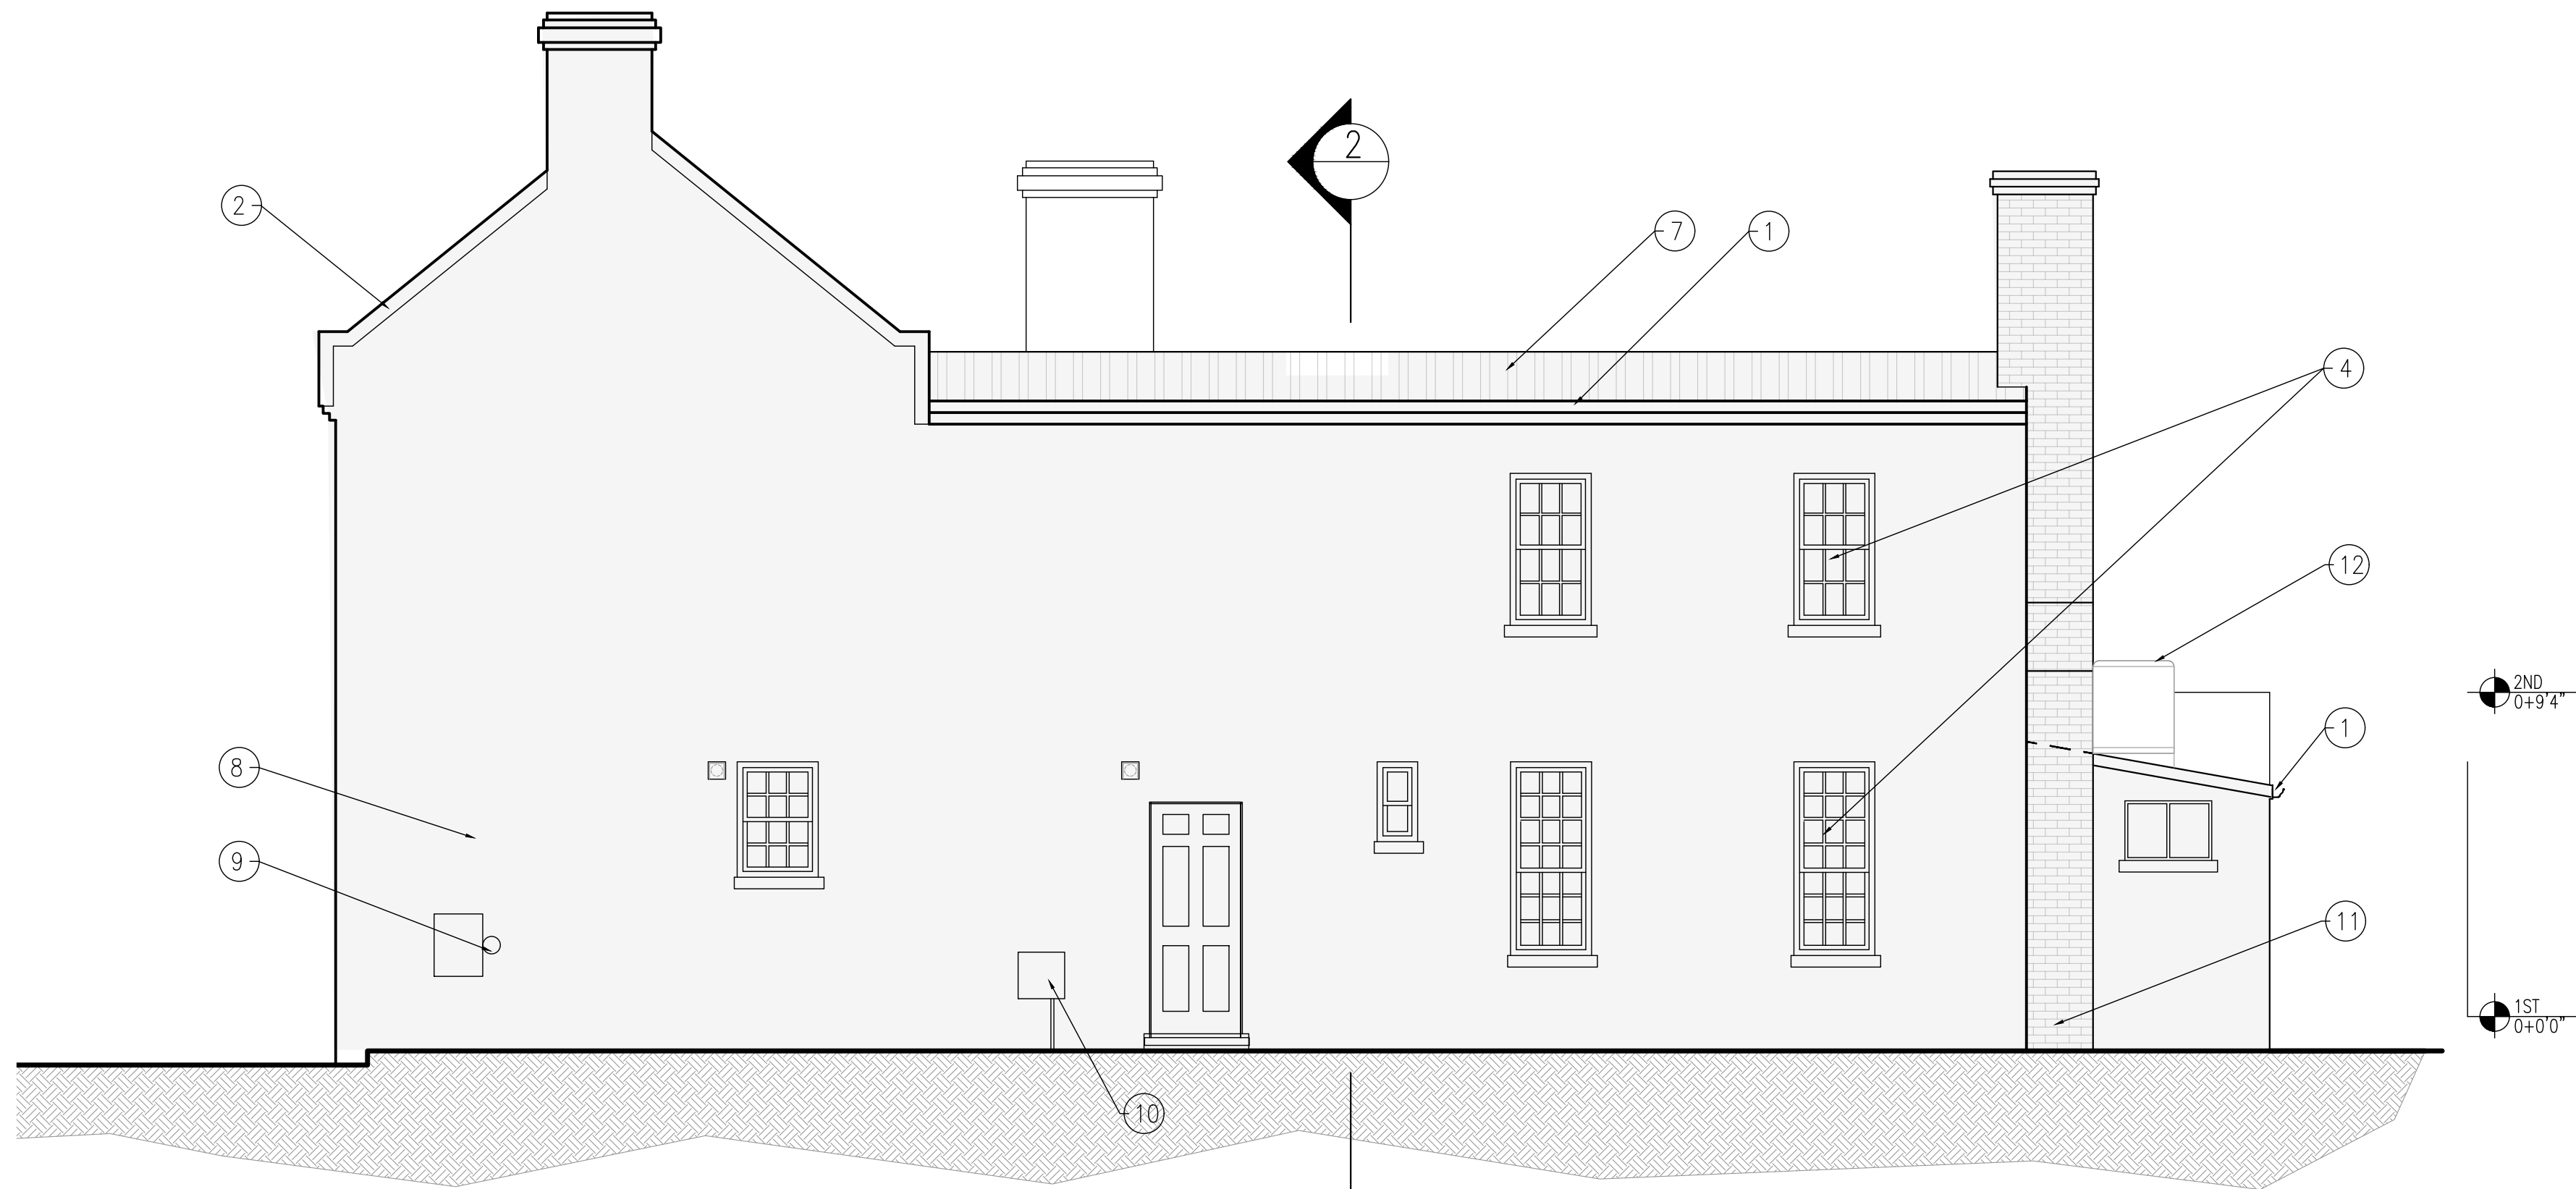
3 RIGHT ELEVATION – EXISTING  
1/8"=1'-0"

- 1. DEMO MTL GUTTER AND DOWNSPOUT.
- 2. DEMO MTL FLASHING.
- 3. DEMO HOUSE NUMBER.
- 4. EX WIN TO REMAIN TYP.
- 5. EX SHUTTERS TO REMAIN TYP.
- 6. CLEAN BRICK.
- 7. DEMO SS MTL ROOF.
- 8. CLEAN AND PAINT STAINED WALLS.
- 9. EX ELEC METER TO REMAIN
- 10. DEMO GAS METER
- 11. REMOVE LOOSE PAINT
- 12. DEMO COMPRESSOR
- 13. REPLACE DAMAGED CONCRETE STOOP.

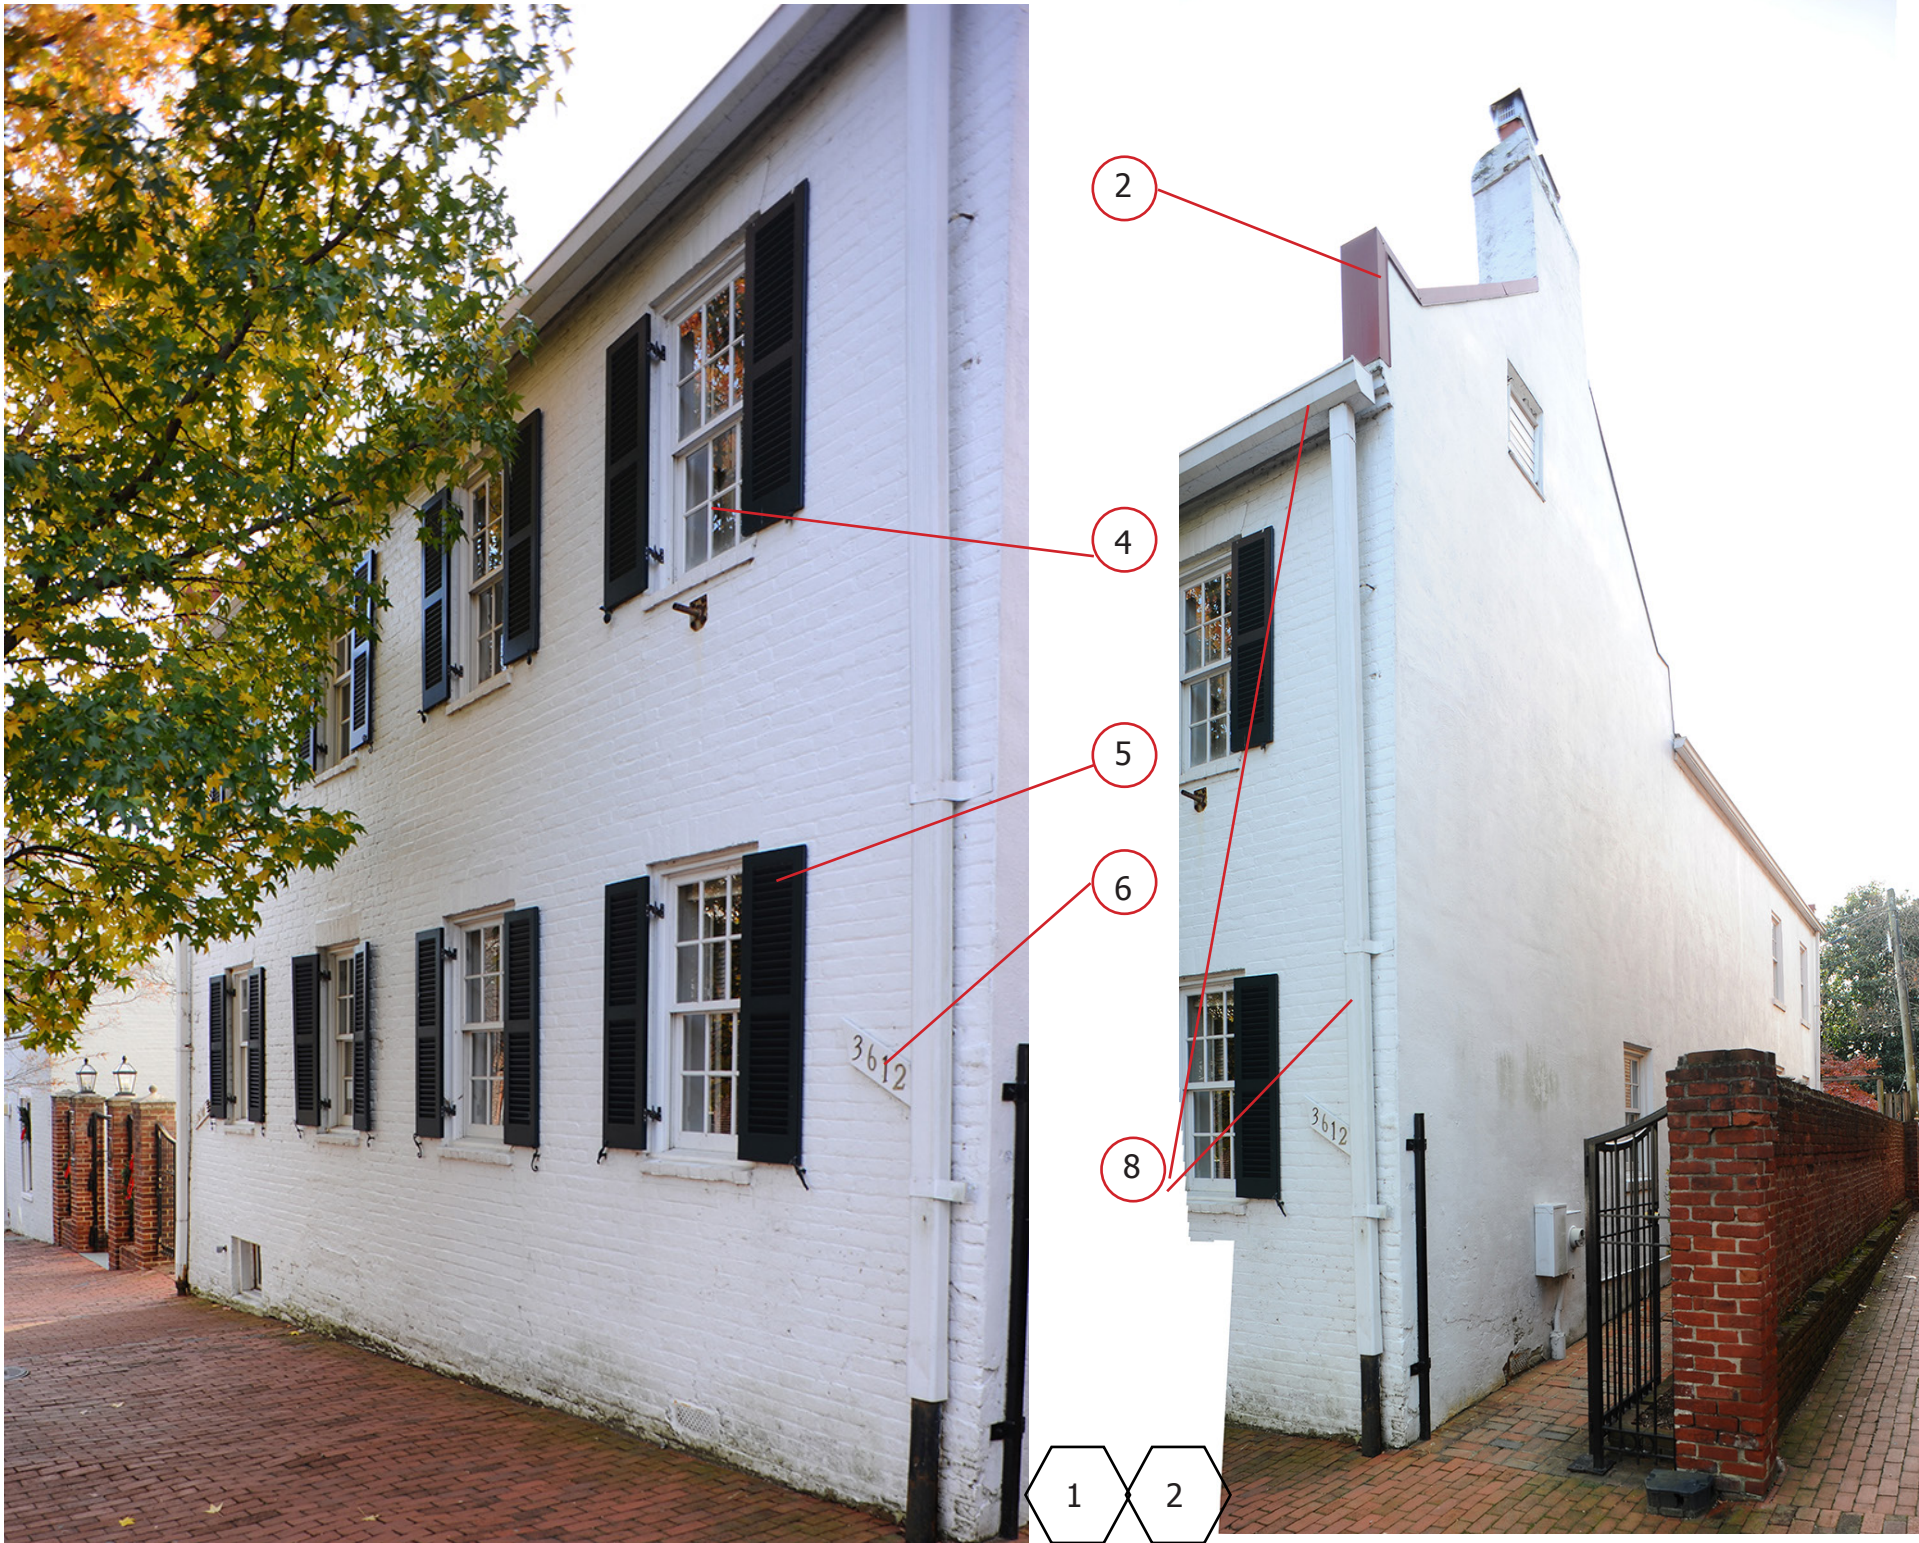
AP1

- Demolition Notes
- 1. Demo roof flashing and roofing
  - 2. Demo metal coping
  - 4. Existing window to remain
  - 5. Remove, refinish and reinstall existing shutters
  - 6. Demo house number
  - 8. Demo gutter and downspout

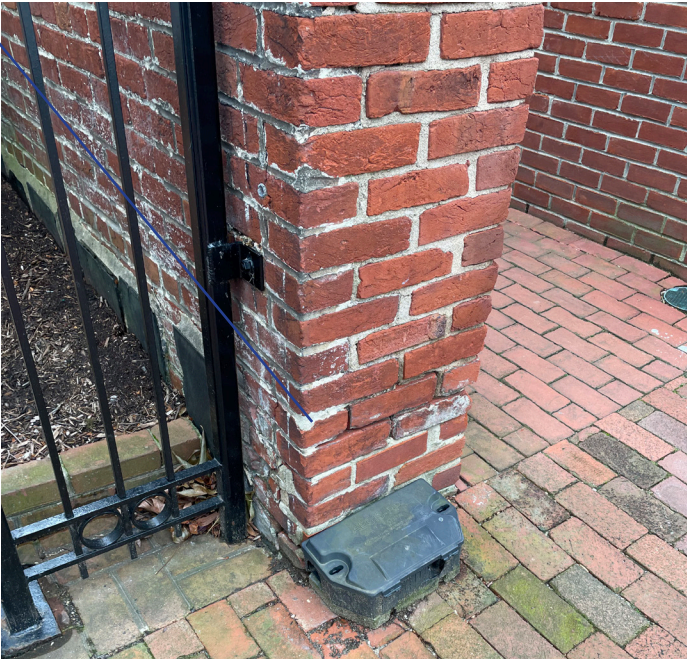
- 3. Remove loose parge, patch and paint
- 7. Demo gas meter
- 8. Demo gutter and downspout
- 14. Reset misaligned pavers
- 20. Replace damaged bricks, reset dislocated bricks, repoint mortar joints with lime-based mortar

One question I had was regarding the alley wall at 3612 O Street. The wall I was referring to was the free-standing brick wall shown on AP2 (not the building wall). The notes say replace damaged bricks, reset cap, repoint mortar joints. What is the cap that is to be replaced and with what material? I also highly recommend specifying a lime-based mortar, given the condition and age of the bricks. Do you have a sense as to how much of the wall will need to be rebuilt?

*The bricks in the wall are in reasonable condition with very few cracked units. There are areas of missing or damaged mortar. The termination pillar for the wall seems to have been struck by a piece of equipment that dislocated the top 6 courses of brick-this is the 'cap' to which I referred.*

*I have added photos to further describe the corrective work we are proposing and noted use of a lime-based mortar.*

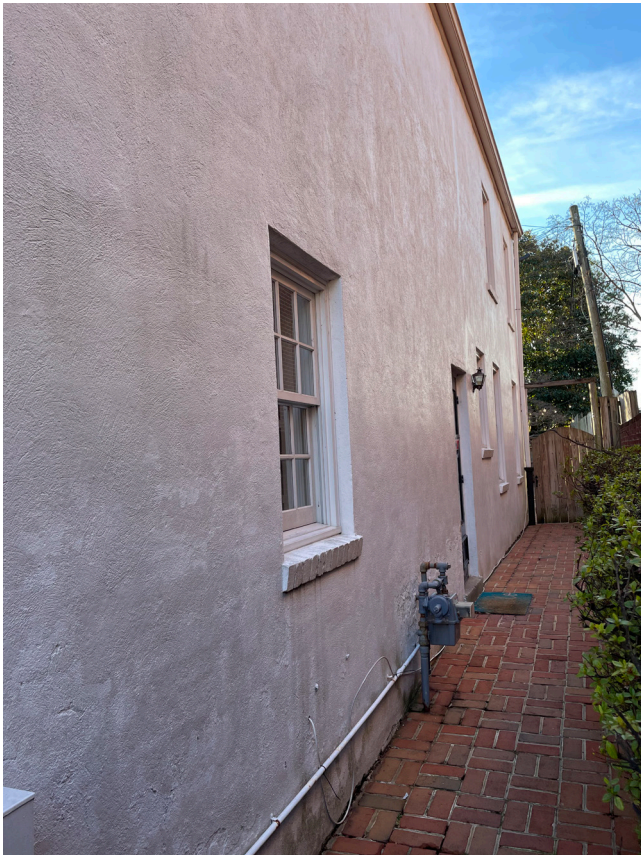
AP3

- Demolition Notes
- 1. Demo roof flashing and roofing
  - 3. Remove loose parge, patch and paint
  - 8. Demo gutter and downspout
  - 18. Demo compressor
  - 19. Replace damaged brick-paint

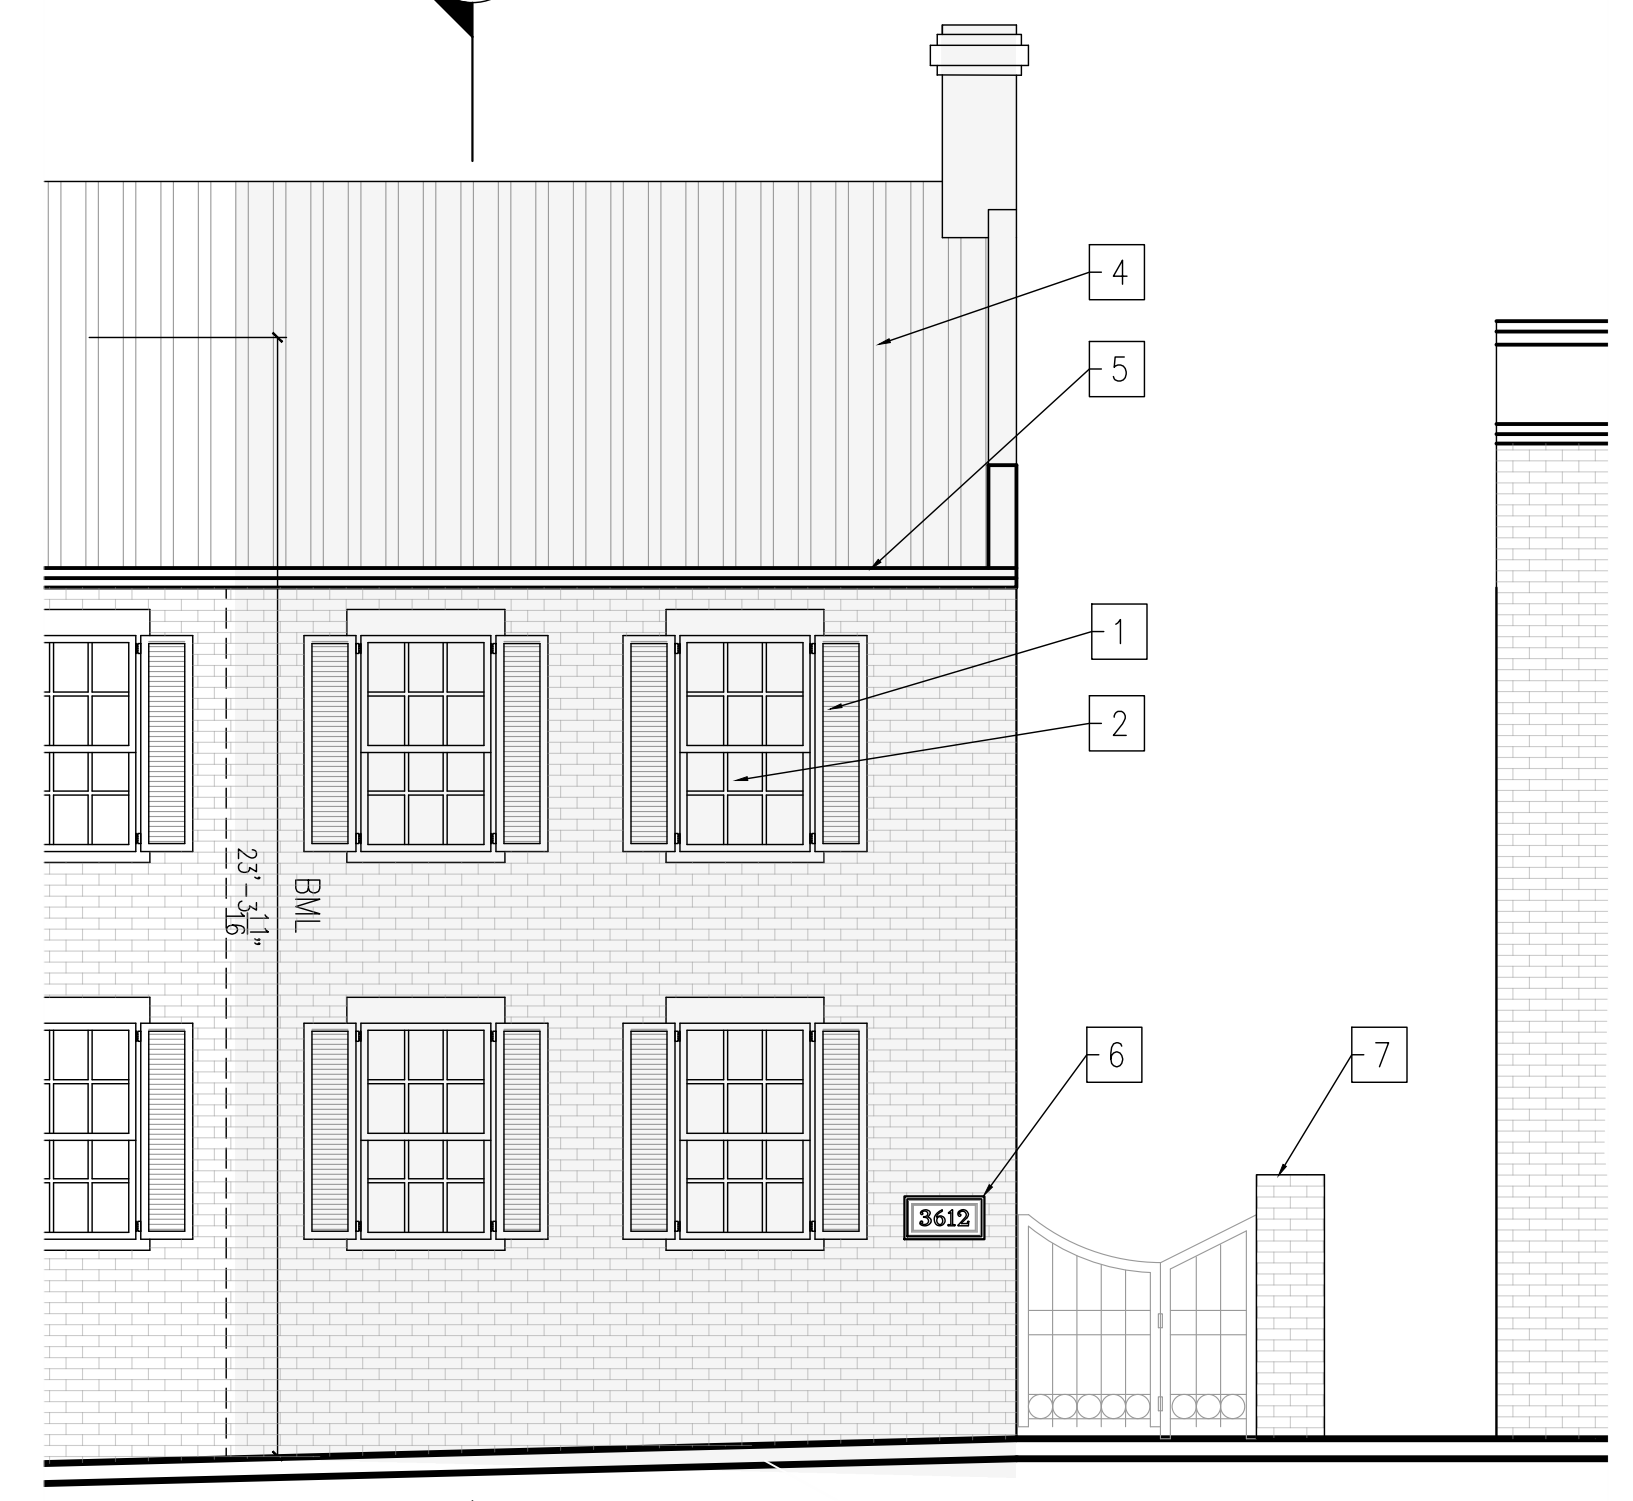
1 FRONT ELEVATION – PROPOSED  
1/8"=1'-0"

- 1. REMOVE, REFINISH AND REINSTALL WD SHUTTERS.
- 2. EX WIN TO REMAIN.
- 3. REFINISH EX DOORS.
- 4. PROVIDE SS COPPER ROOF.
- 5. PROVIDE HALF ROUND COPPER GUTTERS AND DOWNSPOUTS.
- 6. PROVIDE MTL NUMBERS.
- 7. PATCH AND PAINT DAMAGED PARGE WHERE NEEDED.
- 8. REPAIR DAMAGED BRICK PILLAR.
- 9. PROVIDE COMPRESSOR.
